INSPECTION CONNECTION, INC.

ADDRESS: 1150 ACORN ST.

INSPECTION REPORT

1150 ACORN STREET, CHICAGO, IL

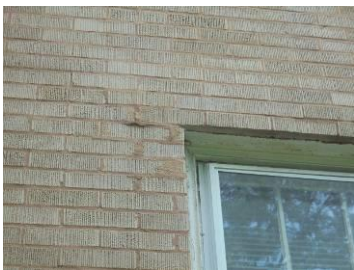
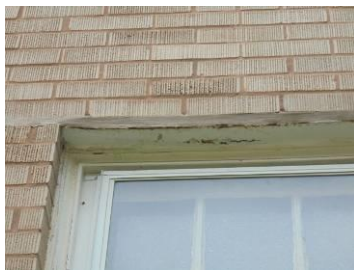
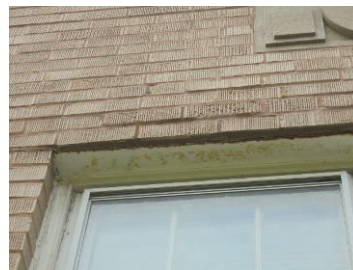
- The lintels are rusting at most of the west and north windows. When steel rusts it expands causing adjacent brick and mortar failure. Approximately 18 lintels are to the point where lintel replacement should be considered in the near future.

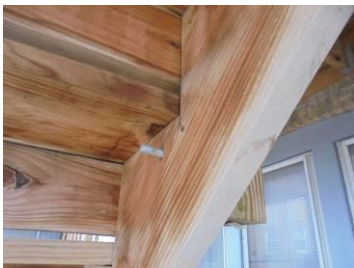
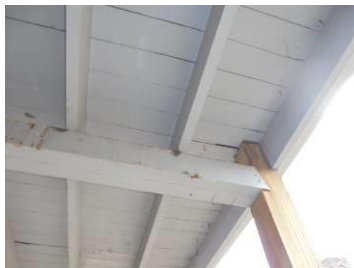
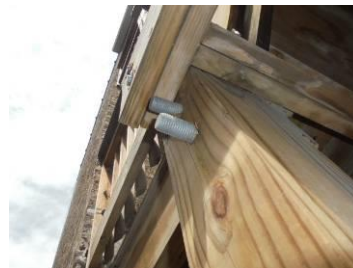
- The back porch is missing hardware at at least a dozen places with bolts missing nuts and washers, corner irons missing at column to beam connections, and corner irons missing at beam to wall connections. Columns should be fastened to their masonry footings. Consult a qualified carpenter.

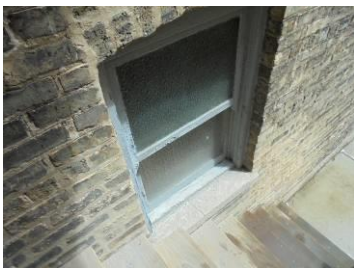
- Note: there is a window next to the west back porch stairway. All windows next to stairways should be safety or tempered glass.

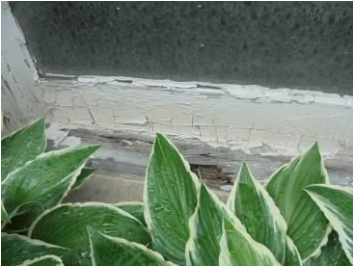
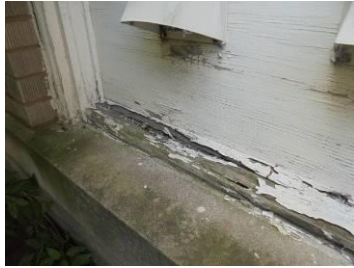
- The windows are in generally poor condition. They are single paned and will not close adequately for a good weather seal. Many have broken glass, deteriorated glazing and defective storm windows. They will be a source of great energy loss in winter. I recommend replacement. Consult a window specialist.
- Two of the basement windows on the north side of the building are rotting out and need replacement.

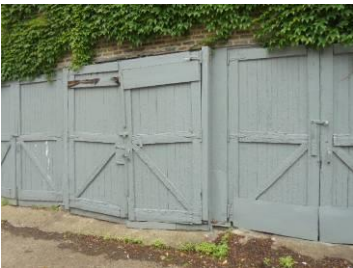
- I did not have access to the garage interior. The doors are in poor condition and need replacement.

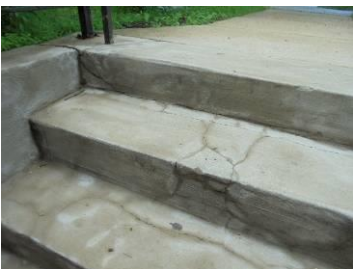
- Do not allow vegetation to grow against the side of the building. Vegetation holds moisture and attracts bugs.
- The masonry stairway at the west side of the building leading to the back porch area is cracking and failing. I expect this to fall apart in the near future. Consult a mason.

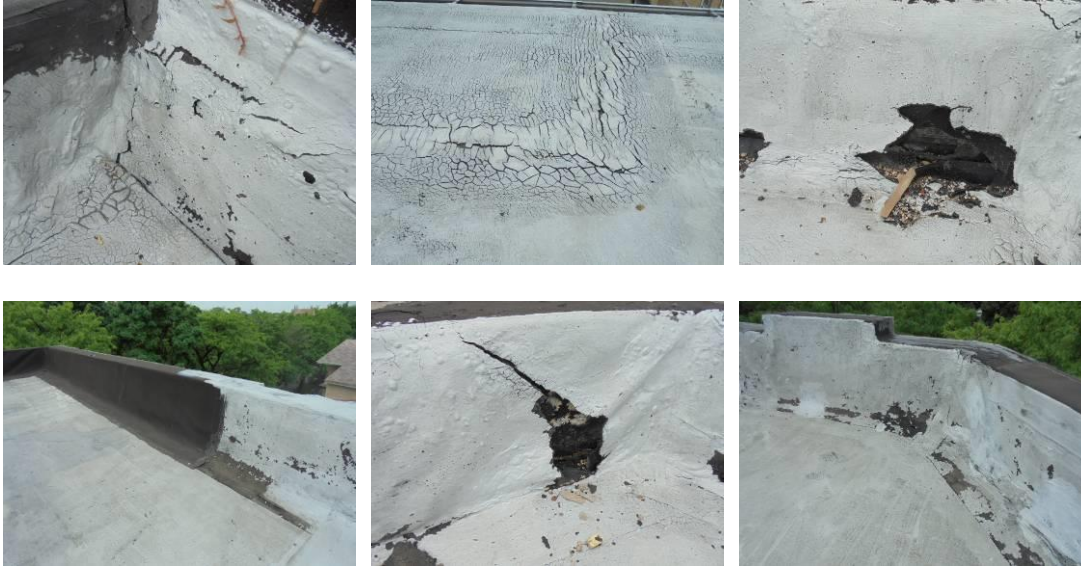
- The modified bitumen roof cover is old and brittle with blistering at a multitude of places. The membrane is cracking and failing apart along parapet walls. There are signs of patching at multiple places and signs of roof leaks inside some of the units. Roof replacement is needed. Consult a roofing professional for estimates on replacement cost.

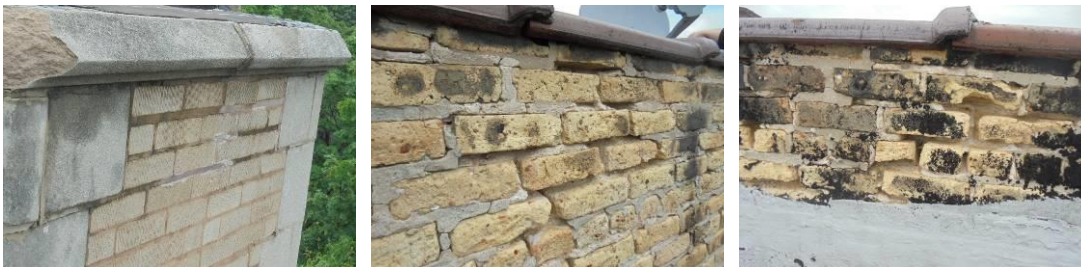
- The roof membrane is not firmly attached to the parapet walls because the parapet masonry is likely failing behind it. The parapet wall will likely need to be repaired and rebuilt around most of the perimeter of the building. This should be done in conjunction with the new roof installation. Consult a qualified mason.

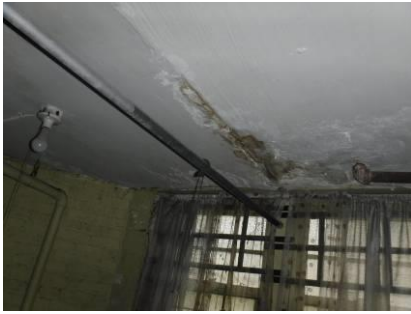
- There are water stains and damage at the ceiling in the middle basement. I was unable to get close enough to see if this is an active plumbing leak.

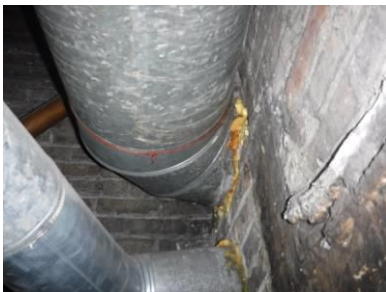
- Note: Did not fire the boiler. I do not know if all of the radiators throughout the building heat up when it is running. I am told that it is operated by a single heat sensor in unit #2E, 7443.
- You should secure from the seller all documentation and contracts for boiler maintenance.
- It looks like someone has sprayed expandable foam where the boiler and water heater vents into the basement wall/chimney. Flammable material should not be in contact with these vents as it may cause noxious fumes.

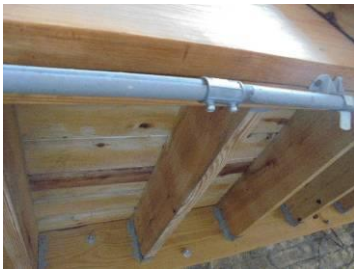
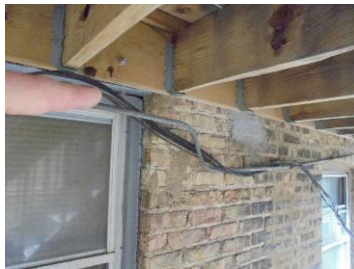
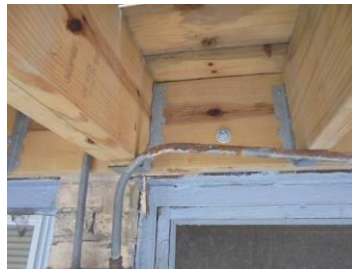
- Only watertight connectors should be used at electrical conduit in wet locations. The wrong connectors are being used at the back west deck. Some of the exterior EMT conduit is rusting and has not been adequately fastened to the building. Consult an electrician.

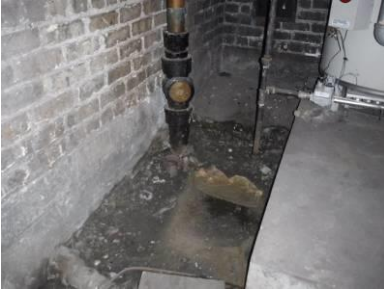
- There is a strong sewage smell in the east basement. It may be coming from a defective sewer line near the east part of the east basement. Consult a licensed plumber.

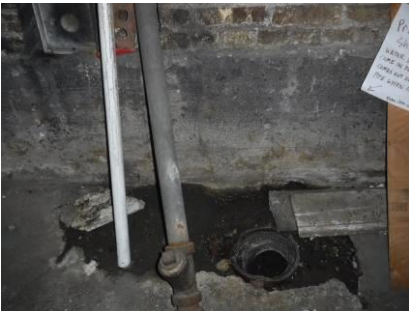
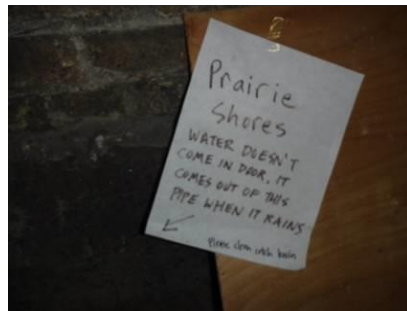
- The east basement shows signs of past flooding. There was a note on the wall concerning sewer backup. It is not uncommon for older to have hidden sewer problems. Drain pipes under the ground can leak attracting tree roots and other blockage problems. These types of problems can be latent so I recommend a TV scope of the underground drain/sewer by a licensed plumber to see if there are any issues.

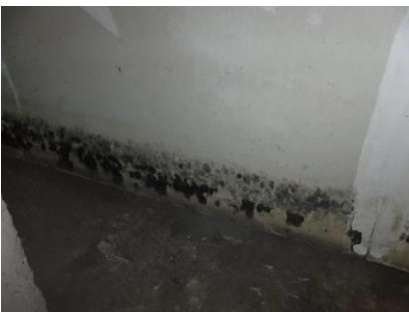
- The drywall is moldy in the east basement. This was likely caused from past flooding problems. Moldy drywall should be thrown away if it cannot be cleaned. Consult the EPA regarding any mold cleanup concerns.

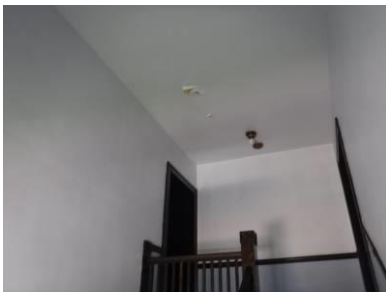
- There is peeling paint at the ceiling in the upper front stairway at the 7441 address. This is likely roof leak related.

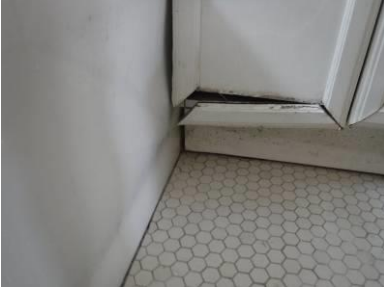
- The drain beneath the kitchen sink is badly corroded and needs repair.
- The radiator has been removed from the bedroom.
- Unit is vacant.
- The bathroom vanity is in distressed condition.

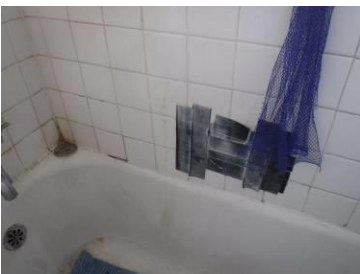
- The bathroom has wall damage next to the tub. Ceramic tile repair is needed.

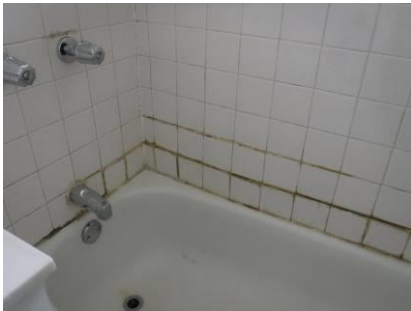
- The ceramic wall tiles in the tub area are failing because the substrate is likely rotted. Tiles will need to be removed and substrate repaired to fix this.

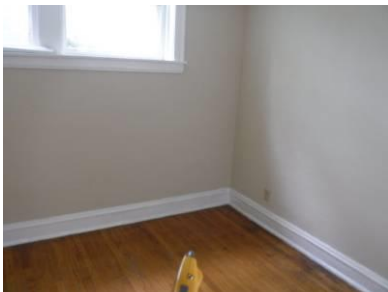
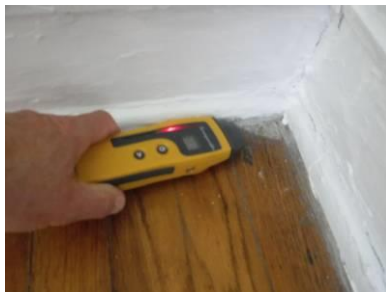
- There are moisture stains and high moisture readings next to the floor in the corner of the bedroom. There is probably a foundation crack with seepage. The wall will need to be opened up so this can be evaluated further and repaired.

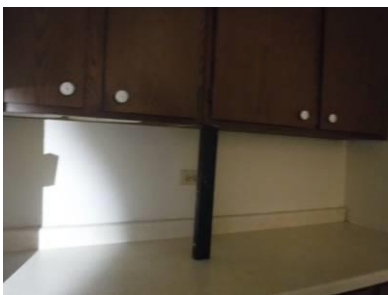
- The garden unit was vacant and had no electrical power.
- The over-the-counter lighting in the kitchen is defective.
- There is a 2 x 4 propped beneath the kitchen wall cabinets. Have a carpenter address this.

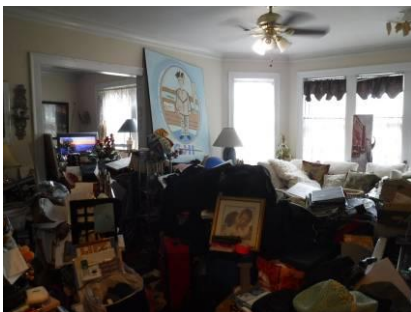
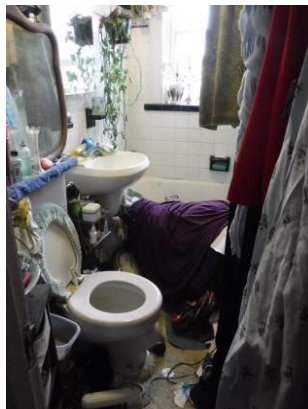
- This unit has excessive clutter everywhere. There was very little room to walk and I was unable to get a good look at the bathroom or kitchen. The unit has a very bad smell.

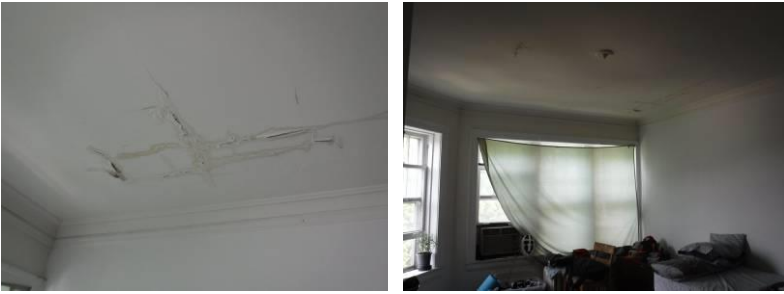
- The front room ceiling is water damaged and wet from an apparent roof leak.

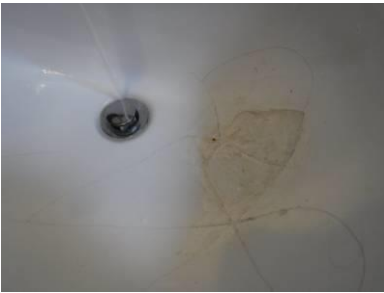
- The sink basin is cracked and needs replacement.

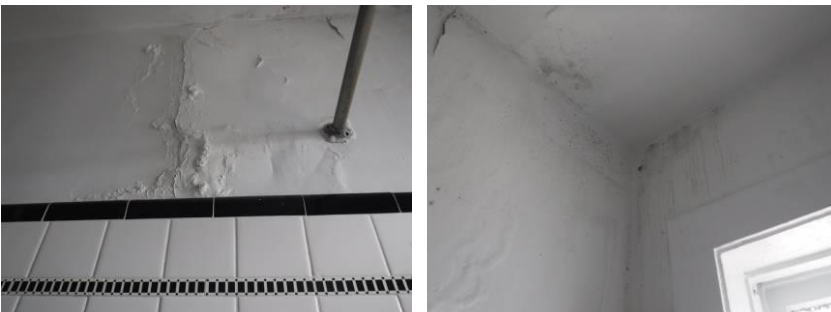
- There is a lot of water damage at the ceiling and wall in the bathroom. This may be caused by the defective toilet above or some other plumbing issue from the unit above.

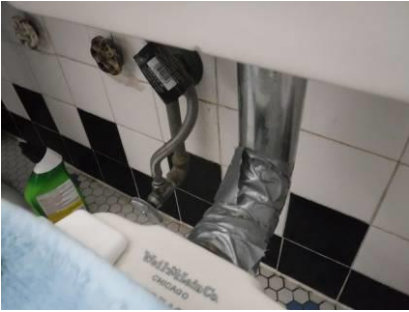
- The water supply from the toilet tank to the bowl has been taped up with duct tape. Have a plumber properly fix this. Note: parts for old toilets can be difficult to find.
